# DC-10

SUBJECT: NACELLES/PYLONS - Attach Fittings - Lubricate/Replace Engines 1 And 3  
Forward Attach Monoball Bearings.

MODELS, All Model DC-10, Series 10, 30, and 40 aircraft, Fuselage No. 1 thru 267.

Bulletin 54-59

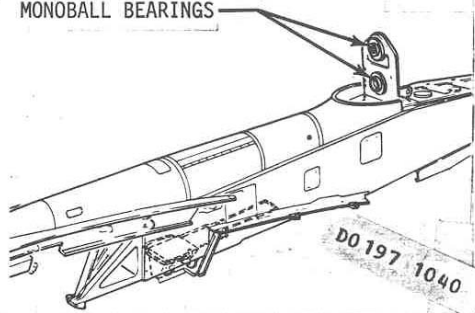
LUBRICATE/REPLACE  
MONOBALL BEARINGS

**ANALYSIS:** Eight operators have reported unsatisfactory performance of the dry film lubricant used on the forward upper and lower wing-to-pylon attach monoball bearings. This condition is due to wear of the dry lube finish on the surface of the monoballs and the presence of corrosion pits on the surfaces which lose the dry lube finish. Corrosion pits have developed on bearings having logged 2000 flight-hours. If not corrected, the corrosion would continue to be a maintenance problem, and the bearings could possibly seize.

**CORRECTIVE ACTION:** Group I - Phase 1 - Lubricate (hand pack) the existing forward upper and lower wing-to-pylon attach monoball bearings. Phase 2 - Revise the plugs for the forward upper and lower wing-to-pylon attach monoball bearings by adding lubrication fittings and replace the dry lube or teflon lined monoball bearings with lubricated bearings. Group II - Accomplish work outlined under Group I, Phase 2.
